## **Periodic Inspection of Jetties at Manasquan Inlet, New Jersey**

**Armor Unit Monitoring for Period 1994-1998**

*by Robert R. Bottin, Jr., WES  
William F. Rothert, Philadelphia District*

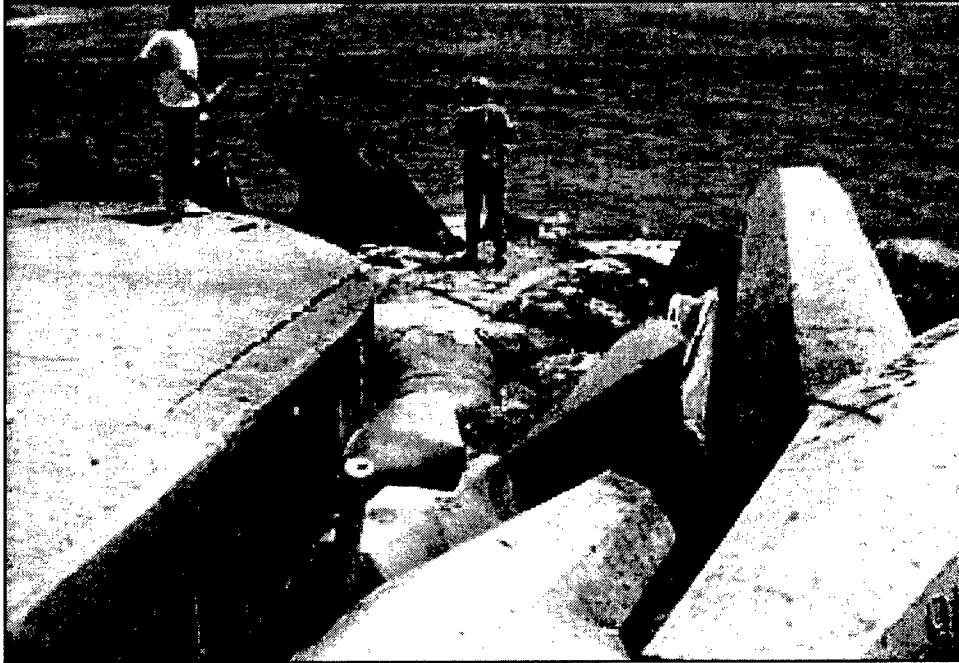
In 1995, maintenance was performed at the tip of the south jetty where core stone under the jetty cap was exposed. Nylon bags were placed in this area, and concrete was pumped into them as a temporary solution (Figure 9). A total of 53.5 cu m (70 cu yd) of concrete was used. This was the first maintenance performed on the jetties since the major rehabilitation was completed in 1982.

Figure 9. Emergency repair work (grout-filled bags) at head of south jetty (performed in 1995)

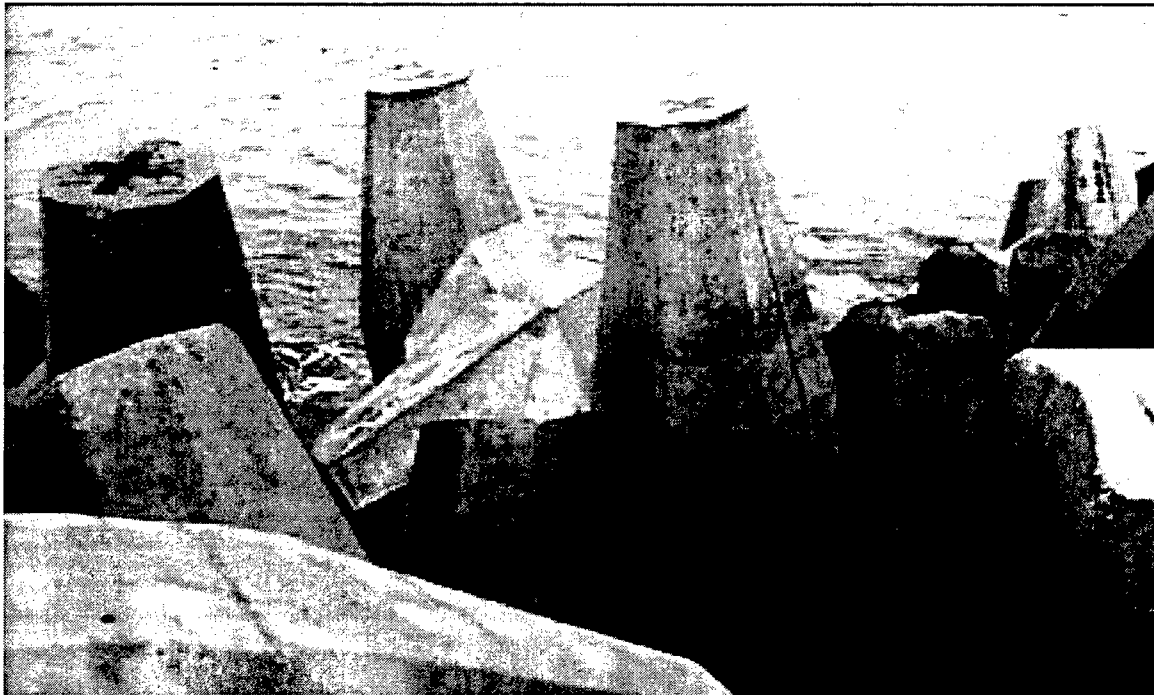
Figure 11. View of 17,235-kg (19-ton) CORE-LOC armor unit on head of south jetty after 1997 rehabilitation

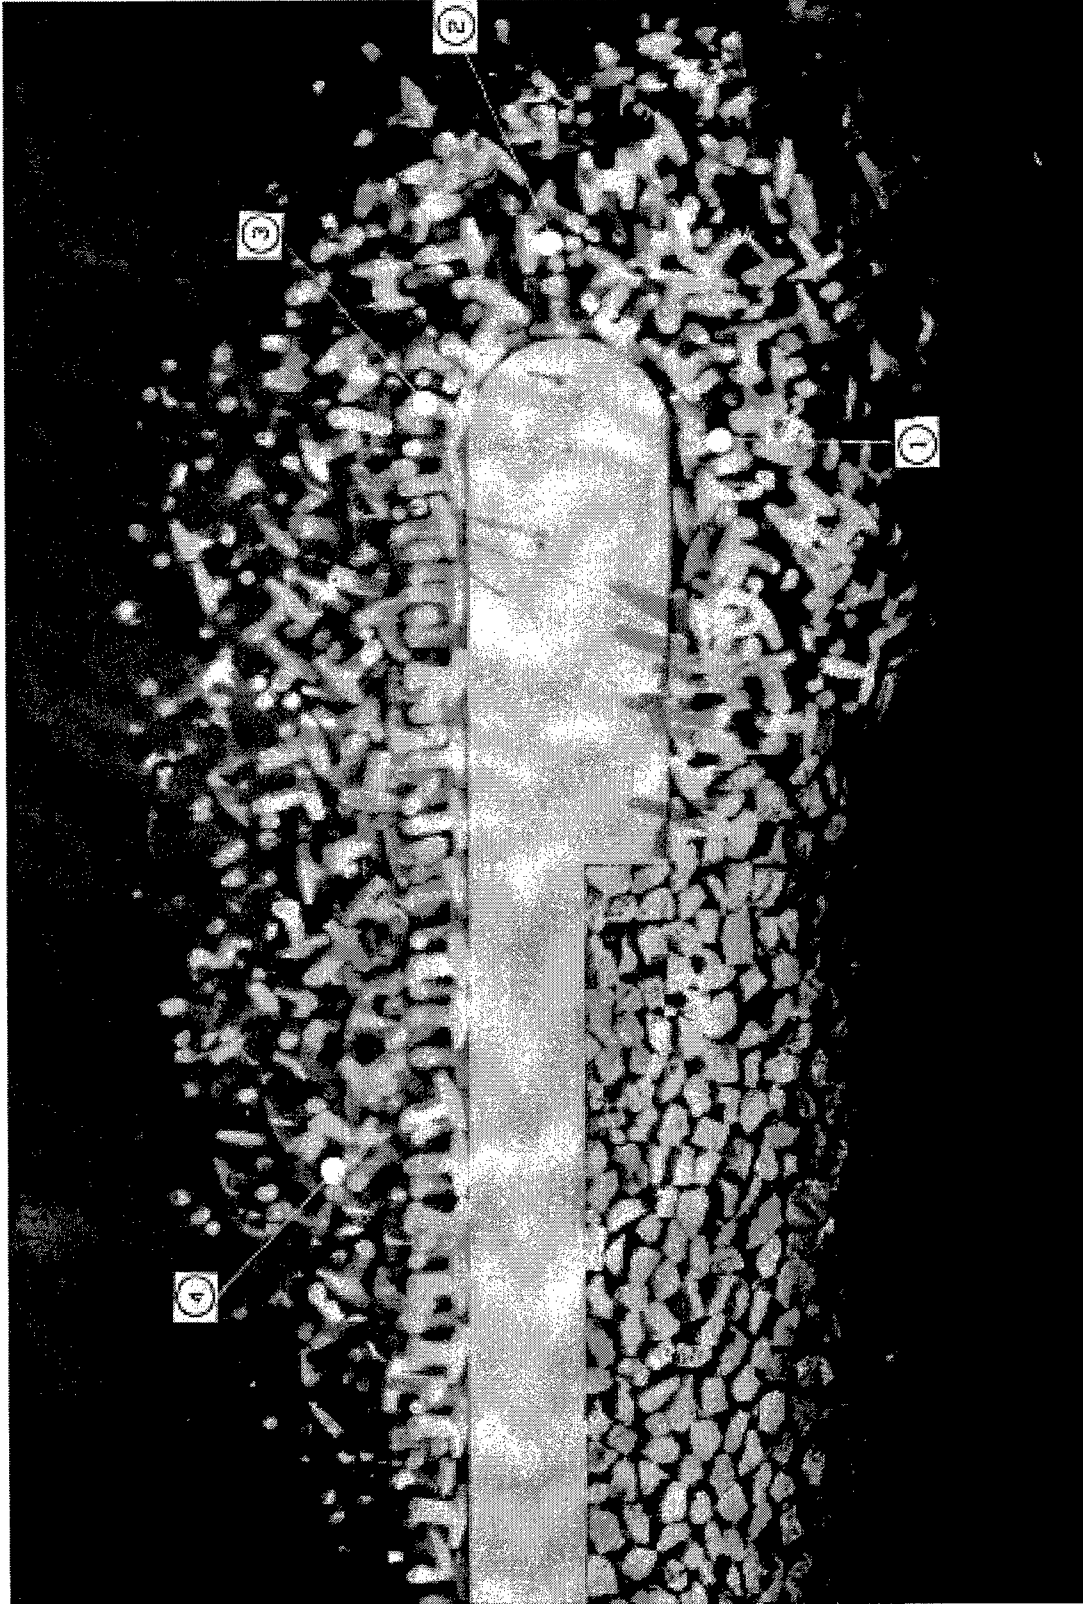
locations are shown in Figures 23 and 24. Some of the data recorded relative to these broken/cracked dolos armor units are shown in Table 4. Of the eight broken/cracked dolos armor units observed, six were identified in the previous (1994) survey, and two (units 1 and 4 on the north jetty) were new breaks.

Figure 23. Approximate locations of broken/cracked dolos armor units on north jetty

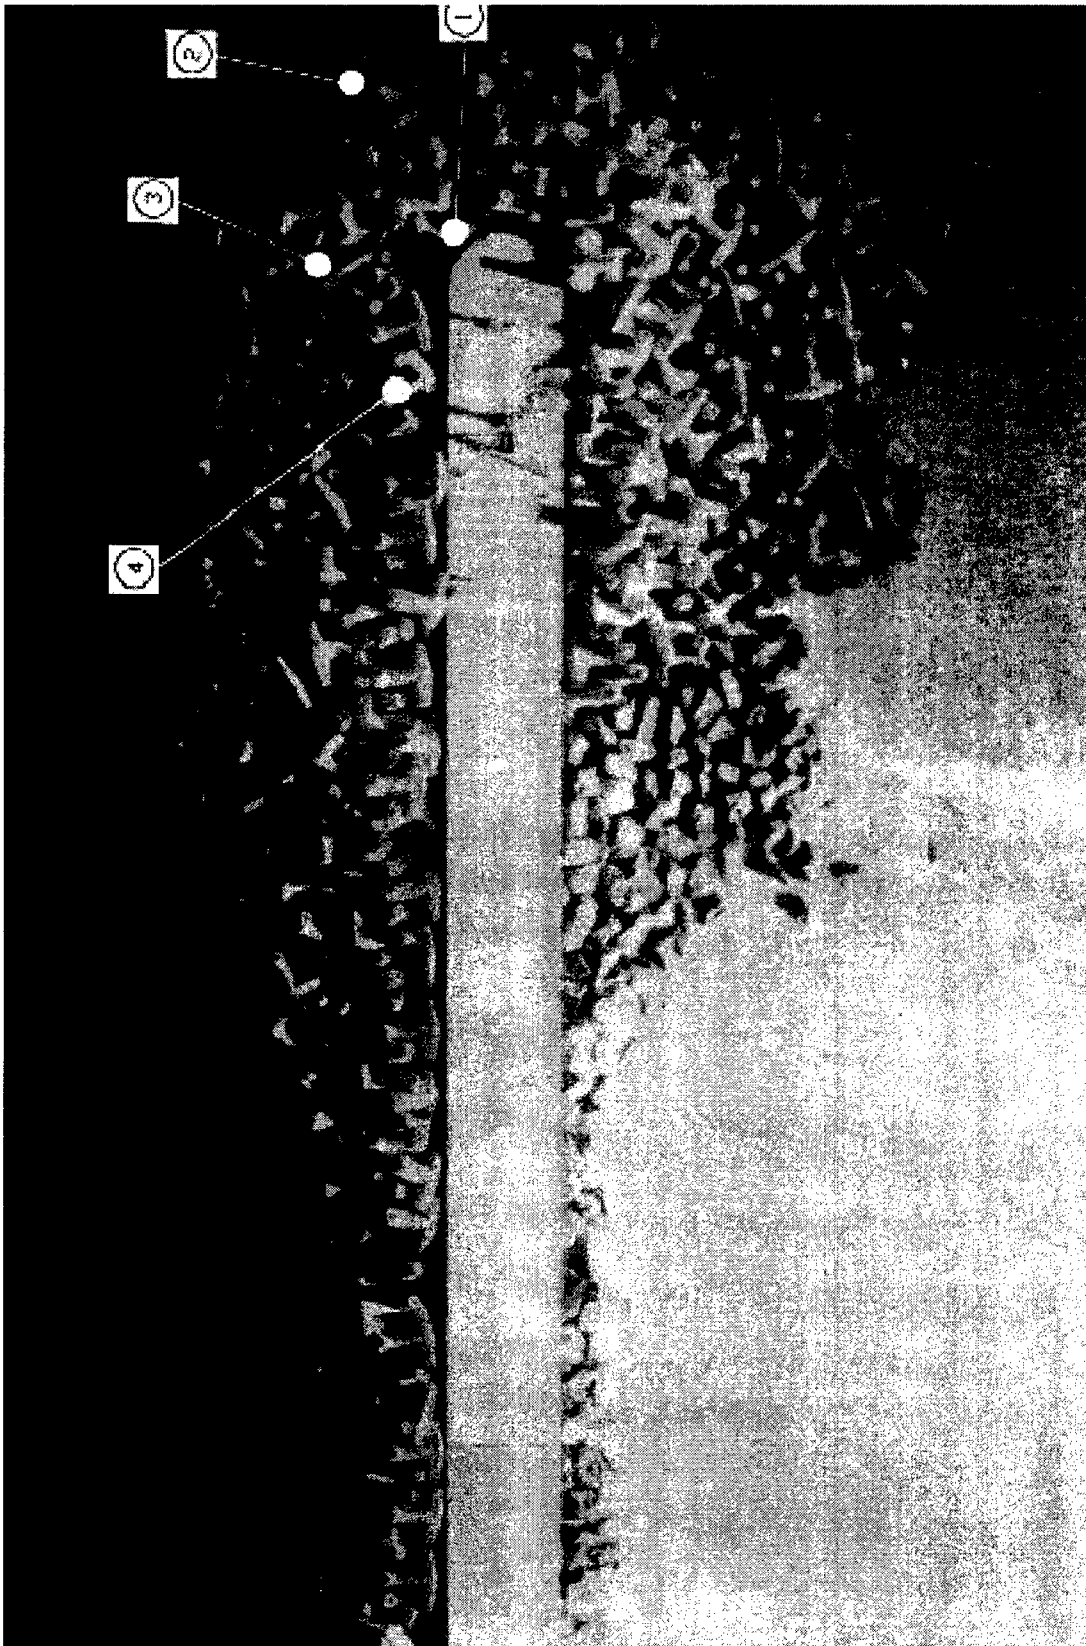
Figure 24. Approximate locations of broken/cracked dolos armor units on south jetty

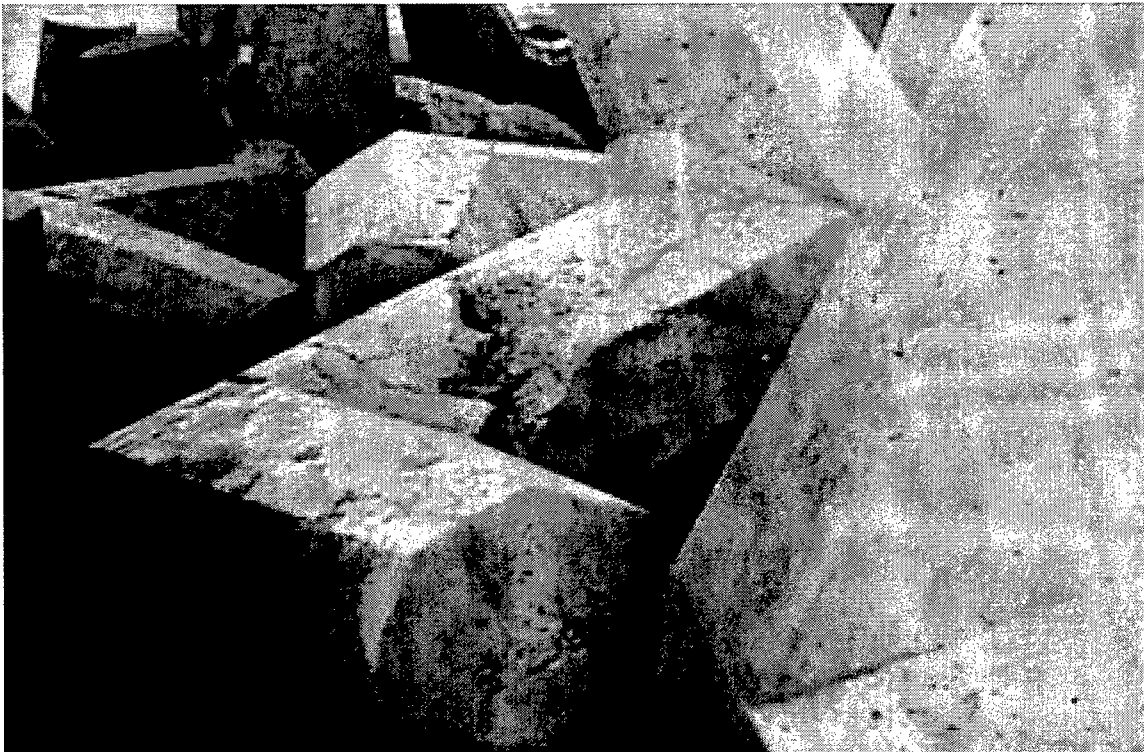
Considering the types of breaks, the majority (six) were shank-fluke breaks. There was one midshank break and one fluke-shank break. There were four angled breaks and four straight ones. Comparison of breakage to production data showed that no production group had an unusual amount of breakage. The distribution of broken/cracked dolosse indicated that seven of the eight units were concentrated around the seaward heads of the jetties, as shown in Figures 23 and 24. Views of typical broken/cracked dolos armor units on the Manasquan Inlet

- (a) stress patterns within the original cast dolosse, (b) handling and placement, (c) settling of the structure, stressing units within the breakwater, (d) wave-induced displacement, (e) wave-induced rocking and fatigue failure, (f) ice pressure and movement, and (g) impact from debris, other dolosse, and dolos fragments.

Figure 25. Dolos with angled midshank break

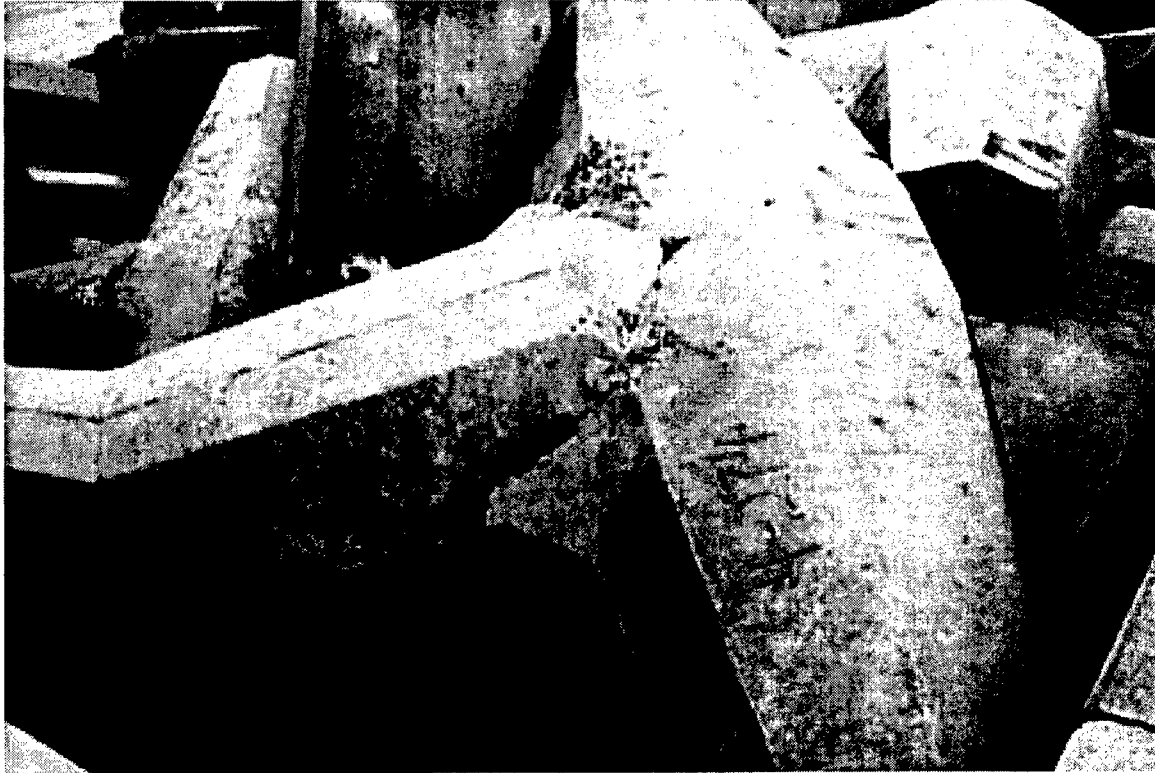
Figure 26. Dolos with angled shank-fluke break

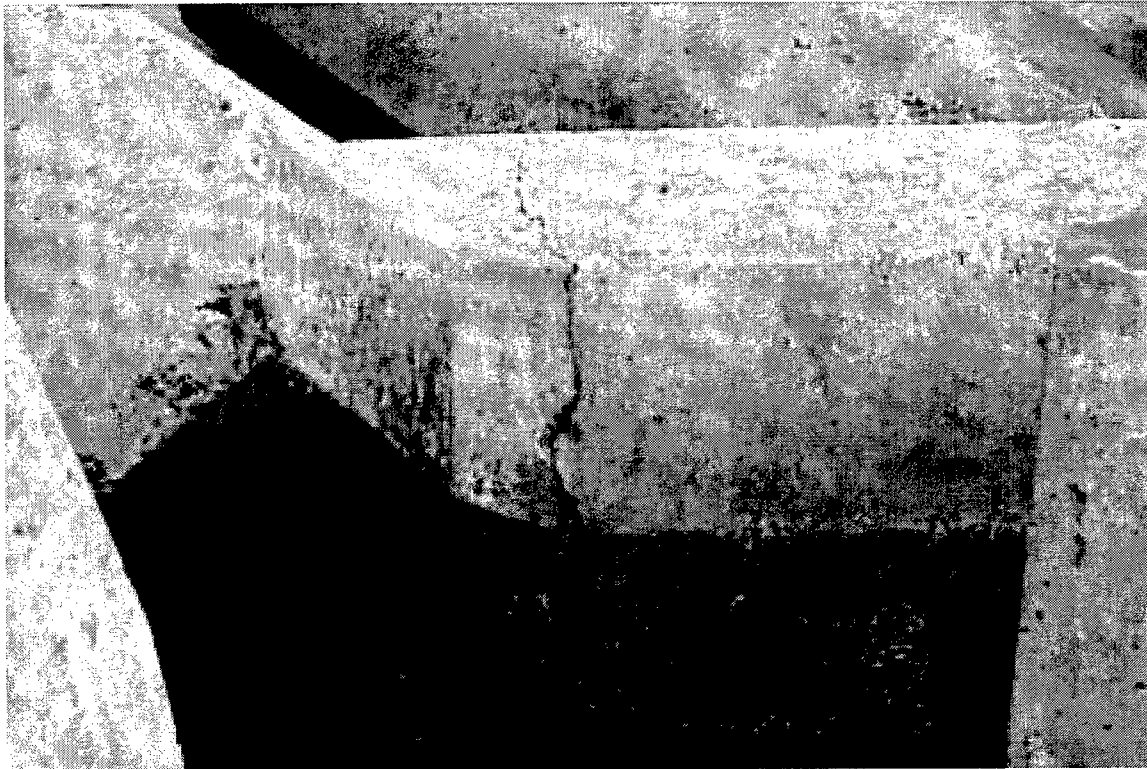
Figure 27. Dolos with straight shank-fluke crack
